Energy 6570/9

New Zealand House Typologies to Inform Energy Retrofits

**A report prepared by Beacon Pathway Limited
November 2008**

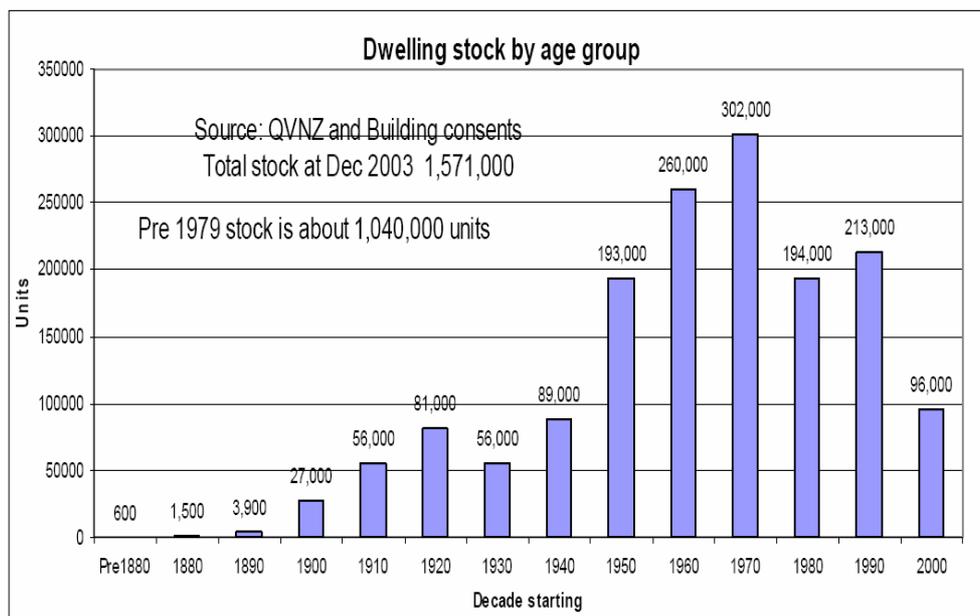
Figure 1 indicates the numbers of houses by age group in New Zealand. Whilst this data does not align itself neatly alongside a set of different typologies based on physical characteristics of housing (e.g. bungalow vs state house), it does provide some understanding about where Beacon’s focus needs to be. In some cases, as with the early housing, it can assist Beacon in determining prevalence of certain modal housing types.

Figure 1: New Zealand’s dwelling stock by decade age group (Storey et al., 2004 as quoted in Amitrano et al., 2006)

The limited number of houses of this type (40–60,000) as indicated in Figure 1 and the essential nature of the heritage characteristics suggest that this category of housing is not a priority for Beacon.

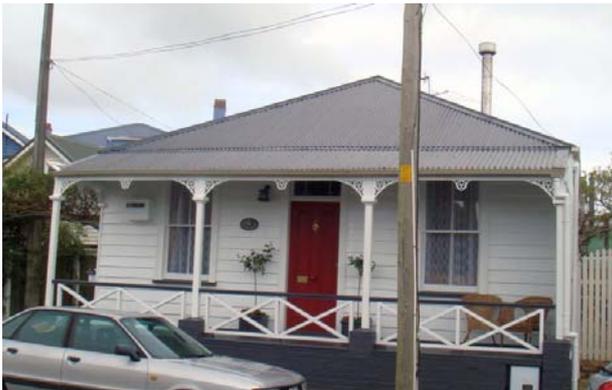
This category describes the simple early housing that was built in New Zealand before the end of the 19th century. The majority of these houses were timber framed, clad in plain or shiplapped weatherboards, with metal roofs. There are some examples of brick and stone being used. The main house form is based on a rectangular plan with a gabled roof and most are single storied. Most had an

open veranda facing the street and a fireplace. More prosperous houses of the period also utilised the roof space. These upper floor rooms are fitted into the attic space of the roof with low walls and sloping ceilings. Houses from this era were built with no insulation. The age of these houses means that those that remain have often undergone a significant number of renovations and alterations including reorientation of rooms, conversion to open plan living, new kitchens and extensions and insulation added in the attic space. From the single rectangle the most basic additions are lean-to roofs to the rear, or additional gabled rooms added behind or as return wings.

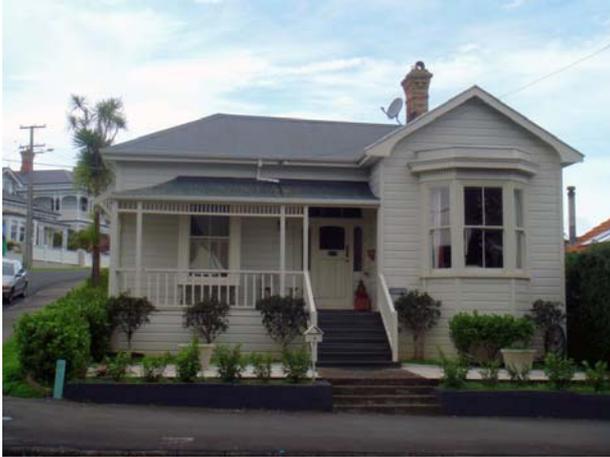
Relatively speaking, villas show little variation within their category compared to other housing typologies. They are typically constructed in native timbers, square in plan with a gabled corrugated iron roof. Notable variants are twin brick and masonry villas with a few cob structures still in existence. Interior walls are typically sarked unless renovated and floors are usually of the suspended native timber tongue and groove variety. These

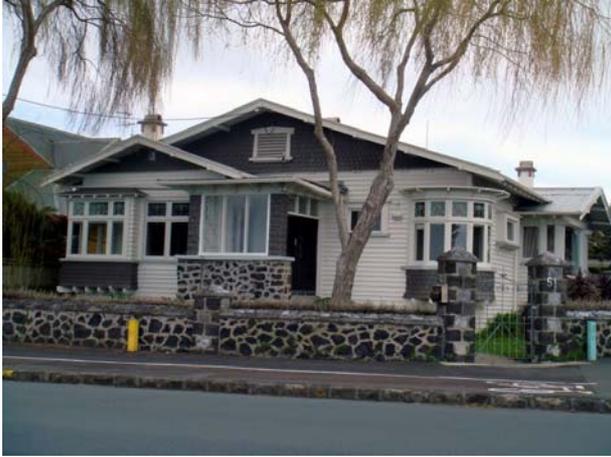
The typical New Zealand bungalow is a relatively simple plan, single storey, gabled home built primarily from native timber and with a corrugated steel roof. A subvariant which may require further research is the English Cottage Style which has 1½ storeys typically and with a large garage or basement underneath. Floors are generally suspended native timber lifted off the ground by more than

500 mm. Wall construction is usually wooden weatherboard with no insulation and no building paper. Some renovations in the 60s and 70s saw the application of brick veneer cladding although solid brick bungalows are rare. The stud height is typically lower than that of villas, commonly being around 2.8 m. Glazing is single in the majority of cases and enclosed in timber joinery except where these have been replaced by single glazed aluminium as part of renovation. Insulation, which was not a requirement at the time of construction, is typically poor throughout although some may have been retrofitted with paper cellulose or older batts in the roof. Almost all bungalows have chimneys unless these have been sealed, with open fireplaces typically in living rooms and sometimes kitchens. Unflued wall heaters are common in areas with reticulated gas. Older style, smaller hot water cylinders are likely to be present in a significant number of these houses presenting an opportunity for retrofit with more efficient cylinders linked to solar or heat pump hot water heating. Bungalows are often oriented to the street rather than the sun. There are pockets of bungalows in neighbourhoods as many of these were built as developer subdivisions.

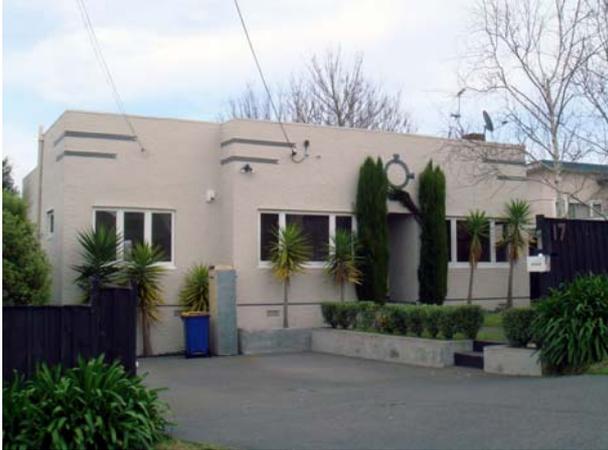
Art deco houses are similar in size and layout to the bungalow though they are constructed using quite different materials and techniques. Typical house size is less than 110 m² and most face the street. The majority are constructed with wooden frames although some are built in brick. Claddings are typically stucco (estimated to be 70%) with a smaller proportion brick (estimated to be 15%) and the remaining

in timber (estimated to be 10%) and fibrolite (estimated to be <5%).² The roof is a key feature of the art deco style, typically featuring a parapet with a flat roof behind. Materials used include steel, mathoid and tile. Failures of the roofing system mean that a significant number of these houses have a new roof installed over the old one. Inside the house the ceilings are often a feature and exhibit ornate plaster work. Heating in the majority of cases will be supplied by plug in electric with few having open fires and wood burners. In terms of regionality many of these houses are located in the Hawkes Bay and in neighbourhoods carved out in the 1930s.

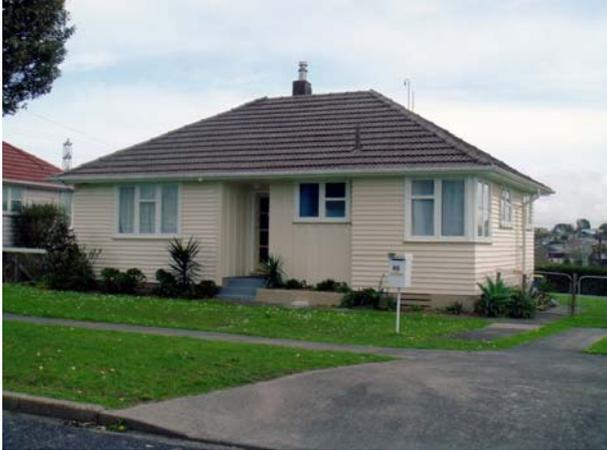
The New Zealand state house is typically small (less than 100 m²) and has a simple square plan. Many state houses show an orientation to the north with living spaces designed to capture the sun as opposed to the early colonial housing which typically faces the street. Roofs are usually hipped and typically have a reasonable pitch (30–40°). Manufactured concrete block starts to appear more commonly as a

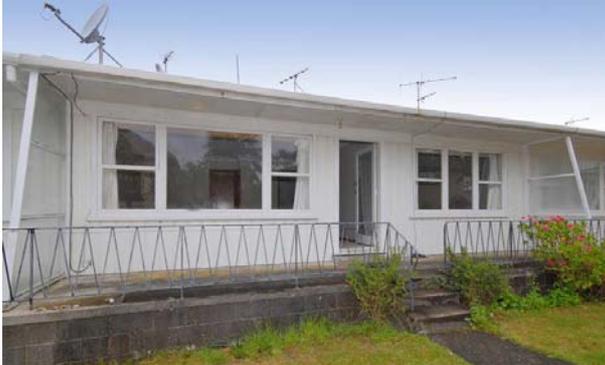
1960s multi unit housing has a typical rectangular house form. Almost all are constructed as light frame concrete block wall on concrete slab, with some brick units evident in some areas. Most are in original condition and rarely have additions or extensive renovations been made. Walls are almost exclusively

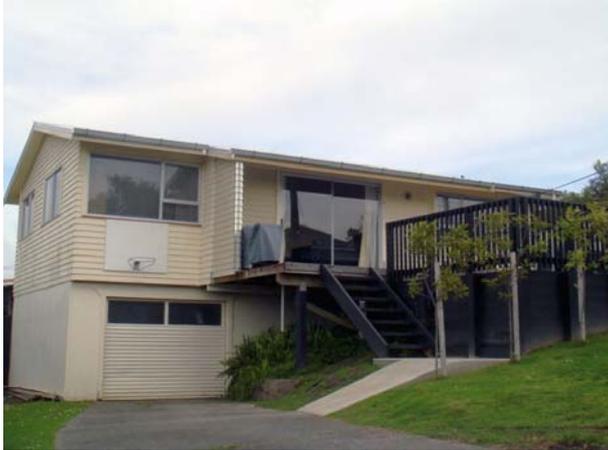
From the 1970s onwards significant variation in both the design and materials used across the housing stock starts to appear. In the period of 1970 through to the introduction of basic insulation standards in 1978, houses in New Zealand were predominantly of timber and chipboard construction with a growing number of examples of concrete construction. Split levels start to appear to

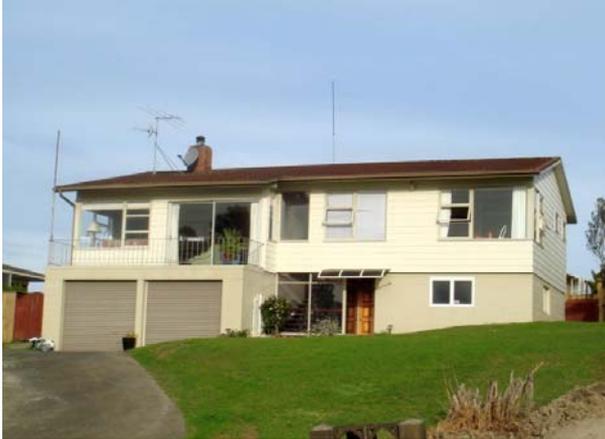
1980s houses exhibit a similar variability to 1970s houses. Many of the houses built in this period appear in Auckland and in high growth areas in the north of New Zealand. Typical construction consisted of timber frame utilising treated pine with cladding in wood weatherboard, fibreboard, fibre cement or brick veneer. Insulation, which is mandatory from 1978, starts to appear in houses although not to a

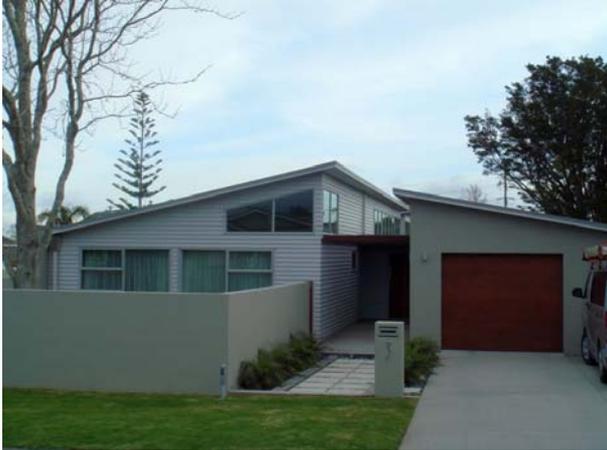
Variation between houses becomes more widespread in this era of construction leading to the possibility of several subtypologies. This may require additional research to develop an understanding of the level of relevant detail and how that might affect the application of retrofit interventions. However, as with other varied typologies, some generalisations can be drawn.

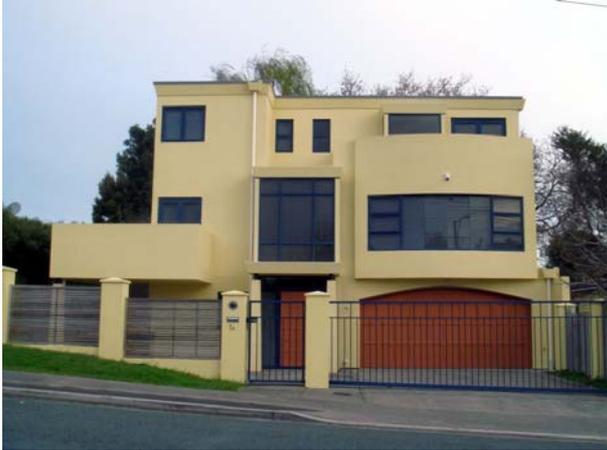
Houses built in the last decade were, in the majority of cases, built as part of large subdivisions and developments. Most could be said to be airtight and well insulated — but a significant number are also prone to leaky building syndrome. Orientation of these houses is typically toward the street — in most cases, to provide vehicle access to large garages that are common throughout. This era sees

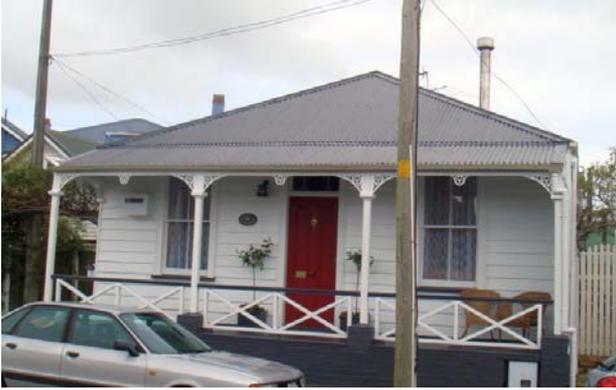
<p>House Type Simple Early Housing</p>

<p>Basic description</p> <ul style="list-style-type: none"> • Principal material — wood (hard timbers) • Large number of modifications homes (e.g. additions, change in lay-out, reorientation of rooms, e.g. moving lounge and bedrooms, open plan living) • Often orientated to road etc., rather than sun 		
<p>Era/age Late 19th century</p>	<p>Main construction type/materials</p> <ul style="list-style-type: none"> • Timber frame • Suspended floors — replaced with concrete piles • Roof cavity usually good, but little or none in the lean-tos) 		
<p>House Form</p> <ul style="list-style-type: none"> • Originally square • Some have attics • Verandahs <p>(Most common example — square box with verandah in front and lean-to at the back)</p>	<p>Estimated percentage Number of storeys</p>		
<p>Location</p> <ul style="list-style-type: none"> • Mostly rural and small towns 	<p>1 storey most houses</p>	<p>2 storey — some houses</p>	<p>3 storey</p>

<p>Main system features</p>		<p>Significant variations (if significant then add to possible subtypes below)</p>	
<p>Floors</p> <ul style="list-style-type: none"> • Timber floor <ul style="list-style-type: none"> ➢ low to the ground ➢ good quality hard wood (often exposed) • Sloping sections (!), majority on flat (?) • Underfloor access can be difficult depending on section 			
<p>Walls</p> <ul style="list-style-type: none"> • Timber frame <ul style="list-style-type: none"> ➢ sarking, serim still present ➢ plasterboard retrofit (?) ➢ more upright framing ➢ a lot of modifications ➢ different distances between joists • External cladding <ul style="list-style-type: none"> ➢ wood ➢ sometimes extensive patching 			
<p>Ceilings</p> <ul style="list-style-type: none"> • Plaster/sarking/some ornate

<ul style="list-style-type: none"> • Wood or plaster 	
Glazing <ul style="list-style-type: none"> • Sash windows • Single glazed/timber • Small panes 	
Roof <ul style="list-style-type: none"> • With cavity — some with attics 	
Insulation None originally — some later retrofited	
Heating system <ul style="list-style-type: none"> • Originally fireplace and coal range — now different types of replacements 	
Other (e.g. garage under house common)	
Can we say anything in relation to climate and/or region?	
Can we say anything in relation to ease of retrofit to Beacon HSS™? <ul style="list-style-type: none"> • Energy • Water • Waste • IEQ • Materials 	
Potential subtypes based on variations	Significant? Estimated % of stock

Typology	Ceiling insulation	Wall insulation	Floor/underfloor insulation	Double/triple glazing
Early housing (pre-1890)	<ul style="list-style-type: none"> - Comfortable cavity to work in - Problems with lean-tos and attics (opportunity at re-roofing stage) 	<ul style="list-style-type: none"> - Good opportunity when refurbishing and replacing plasterboard or external weatherboards - Need to be careful about moisture issues in relation to lack of building paper - Potential with weatherboards — but age is a constraint (as they split) 	<ul style="list-style-type: none"> - If good access under the floor (greater than 400 mm and suitable sized access door) then this is possible - Due to modification polystyrene blocks difficult (different distances between joists) — polyester rolls would be easier 	<ul style="list-style-type: none"> - Character/heritage is a constraint - Secondary glazing has more potential than replacing whole windows - No standard — more expensive - Plastic film glazing may be suitable for windows that are in less noticeable parts of the house (e.g. back bedrooms)

Typology	Heat pump	Low emission wood burner	Pellet burner	Heat transfer systems
Early housing (pre-1890)	<ul style="list-style-type: none"> - Very few issues - Noise? (in close proximity neighbourhoods) 	<ul style="list-style-type: none"> - Floor plan and space availability - Floor strength 	<ul style="list-style-type: none"> - Floor plan and space availability - Floor strength 	<ul style="list-style-type: none"> - Roof cavity available to be used
Villa (1880–1920)	<ul style="list-style-type: none"> - Heritage issues depending on where external unit located - Ducted or multiple systems may be required - Sized correctly important (as with all houses of any age) 	<ul style="list-style-type: none"> - Should be easy inside existing fire place 	<ul style="list-style-type: none"> - Similar for wood burner 	<ul style="list-style-type: none"> - Easy but air volume issues - Central heating using radiators or underfloor ducting options could also be explored

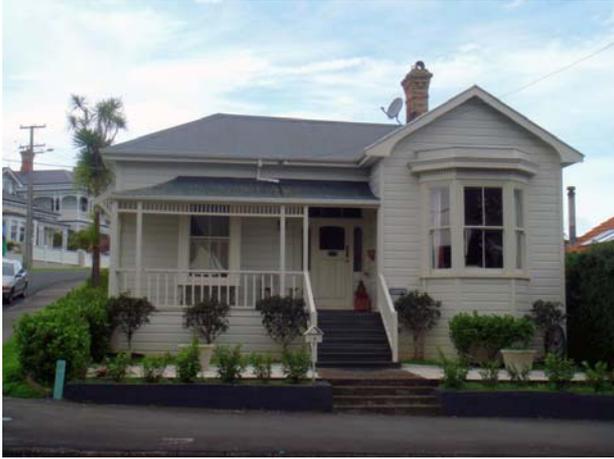
House Type Villa

Basic description		
	House Form Square and simple		
	Main construction type/materials Iron and native timber some thermal mass in chimneys		
	Estimated percentage Number of storeys		
Era/age 1900–1920	1 storey most	2 storey some	3 storey
Main system features Solid structure, highly adaptable, serious architectural features		Significant variations (if significant then add to possible subtypes below)	
Floors 6 inch or wider floorboard			
Walls Sarked unless renovated; hallway lined		Some high thermal mass, twin brick, cob, pebble	
Ceilings 12 ft stud		Coved ceilings difficult to insulate	
Glazing Wooden joinery, single glazed, sash = complicated Multipane = non-retrofittable			
Roof Iron; large cavity; high pitch; inbuilt			
Insulation Roof and renovated walls? No building paper			
Heating system Complete gamet; unlikely to be only electric; solid fuel common; heat transfer			
Other (e.g. garage under house common)		2 storey often converted into multiple flats

Can we say anything in relation to climate and/or region? Large range of current condition/states			
Can we say anything in relation to ease of retrofit to Beacon HSS™?			
<ul style="list-style-type: none"> • Energy

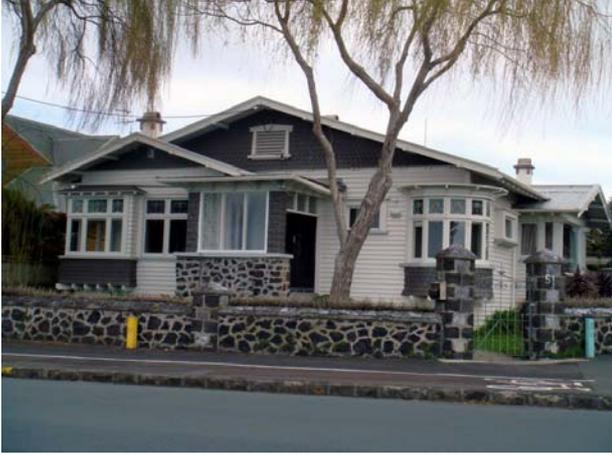
<p>House Type Bungalow</p>

<p>Basic description Single story gabled home. There is a subvariant, the English Cottage Style, which are all 1½ stories with generally a garage/basement underneath</p>		
	<p>House Form</p>		
	<p>Main construction type/materials Wooden weatherboard (rimu), wooden floors (rimu or matai), corrugated steel roof</p>		
	<p>Estimated percentage Number of storeys</p>		
<p>Era/age 1915–1930</p>	<p>1 storey 99% bungalows</p>	<p>1½ storey 99% of English Cottage style</p>	<p>3 storey</p>
<p>Main system features</p>		<p>Significant variations (if significant then add to possible sub types below)</p>	
<p>Floors Always have a suspended timber floor. Mainly greater than 600 mm and often very high underneath (for Dad’s shed)</p>			
<p>Walls Wooden weatherboard, no insulation, no building paper. Some now clad in brick veneer as a result of 60s and 70s renovations; brick bungalows are rare, as some with stucco over chicken wire and fibro cement</p>

<p>Ceilings Stud height around 2.8, originally cast plaster ceilings with pseudo beams. Cavity ceilings and roofs framed with 100 x 50 rafters</p>			
<p>Glazing Wooden joinery with casement windows and fanlights above, in the 60s and 70s these were often replaced with aluminium windows single glazed</p>			
<p>Roof Pitched roof 24–27° (can be down to 18°), mostly steel, some tiled and some asbestos sheet in tile form or corrugated form</p>			
<p>Insulation Paper mache in ceiling or early batts common, walls uninsulated, underfloor insulation uncommon</p>			
<p>Heating system All have chimneys (mostly in living room, sometimes in kitchen also), wall</p>

gas heaters are common in reticulated areas of the North Island	
Other (e.g. garage under house common) Garages independent, popped tops from 80s onwards common, lean-tos not that common	
Can we say anything in relation to climate and/or region? Always oriented to the street not the sun Built as developer subdivisions as population centres expanded, so whole neighbourhoods of bungalows	
Northern parts of the country wood burners with wet backs are common, many areas wood burners retrofitted into chimney space	
Can we say anything in relation to ease of retrofit to Beacon HSS™?	
<ul style="list-style-type: none"> • Energy — relatively easy to insulate underfloor and ceiling — main issue is underfloor access if less than 400 mm, often get slumped floors; big issue for retrofit is draughts through windows — requires fiddly draught stopping and draught stopping products are poor quality • Sashes of windows won't take the weight of double glazing • Insulating does result in drying of floorboards and gaps resulting (lino can lift and bubble) • Lots of DIY wiring under houses — health and safety risk for stapled foil products but OK for batts and polystyrene • Is a concrete foundation under the chimney and sometimes for setdown porches and these areas are uninsulatable • If insulate walls the architects consider should put in building paper otherwise will create a condensation point in walls and create rot — ventilation and removal of moisture from within home would address this issue • Open fires are commonly used, and wet backs are common in rural areas • Old small electric hotwater cylinders (low pressure) are still common — can be 50 years old

Typology	Ceiling insulation	Wall insulation	Floor/underfloor insulation	Double/triple glazing
Bungalow (1920– 1930/40)	<ul style="list-style-type: none"> - Not a problem — similar to villa as above 	<ul style="list-style-type: none"> - In cold climates have to insulate walls or wasting time - Rot and Bora may throw up structural issues - Small sections of timber — lots of thermal breaks — also have to upgrade wall - No building paper so condensation an issue - Have to get rid of internal moisture first 	<ul style="list-style-type: none"> - Not a problem — similar to villa as above 	<ul style="list-style-type: none"> - Heritage issues — too expensive to retrofit double glazing into wood - For effective solution need to use thermally broken panes - Removing draughts in windows a key issue
Art Deco (1925–1935)	<ul style="list-style-type: none"> - Flat roof very tricky - Plasterboard ceilings desirable - May have secondary roof 	<ul style="list-style-type: none"> - Difficult to replace external cladding so unlikely to get access from outside - Inside decoration and features may require protection (heritage and character) 	<ul style="list-style-type: none"> - Lower to ground so access may be an issue - Have concrete piles 	<ul style="list-style-type: none"> - Unlikely solution as windows a feature - Thermal curtains and pelmets may provide the best solution

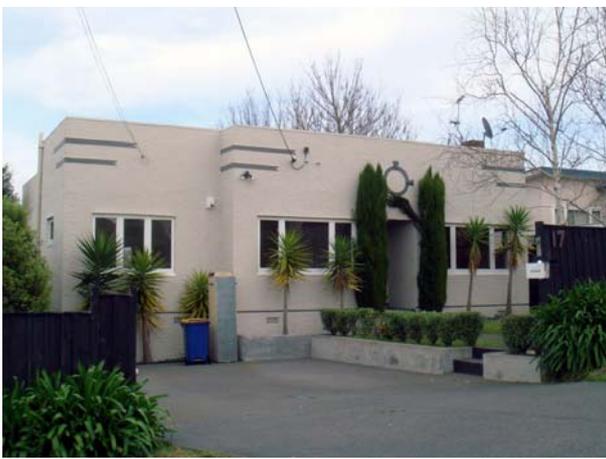
<p>House Type Art Deco</p>

<p>Basic description Similar size and layout to a bungalow 3–4 bed, have curves!</p>		
	<p>House Form <110m² curved, face the road</p>		
	<p>Main construction type/materials Wooden frame majority (minor brick) Stucco 70%, brick 15%, timber 10%, fibrolyte (<5%)</p>		
	<p>Estimated percentage Number of storeys</p>		
<p>Era/age 1931–1939 Traditionally seen as a Spanish style (curved front) 1931–39, 1934–40 depression, war</p>	<p>1 storey 90</p>	<p>2 storey 10</p>	<p>3 storey</p>
<p>Main system features Whole house poorly orientated. Poor internal layout</p>		<p>Significant variations (if significant then add to possible sub types below)</p>	
<p>Floors Suspended timber strip (high value wood matai), concrete piles</p>			
<p>Walls Wooden frame (majority), rest brick. Stucco 70%; timber 10% /panels fibrolight 5% /brick 15%. Difficult to access for insulation</p>			
<p>Ceilings Ornate plaster. High stud 8–9 ft</p>

<p>Glazing No eaves, <20% of wall area, leadlight features. Pelmet fashionable (70–80%)</p>			
<p>Roof key feature Parapet with x-flat roof behind (80%) - steel - mathoid - tile Failures mean some have a new roof built over existing — difficult/impossible to insulate because of air gap Hipped roof (20%)</p>		<p>Christchurch reroofed over fouled mathoid (with ventilation gap so insulation useless)</p>	
<p>Insulation 40% no ceiling insulation; <5% floors; <2% walls</p>		<p>Ceilings — ornate plaster; people want to keep</p>	
<p>Heating system Plug in electric — 68% Open fire — 15% Wood burner — 10% Heat pumps — 7%</p>			
<p>Other (e.g. garage under house common) Garages if home built on hills</p>

- steel
 - mathoid
 - tile
 Failures mean some have a new roof built over existing — difficult/impossible to insulate because of air gap 1:1 roofs
 Hipped roof
 Insulation — 40% no ceiling insulation; <5% floors; <2% walls
 Ceilings — ornate plaster; people want to keep
 Heating system
 Plug in electric — 68%
 Open fire — 15%
 Wood burner — 10%
 Heat pumps — 7%
 Region — Hawkes Bay
 But nationally small pockets and streets (suburbs)
 Retrofit — bungalow with flat roof

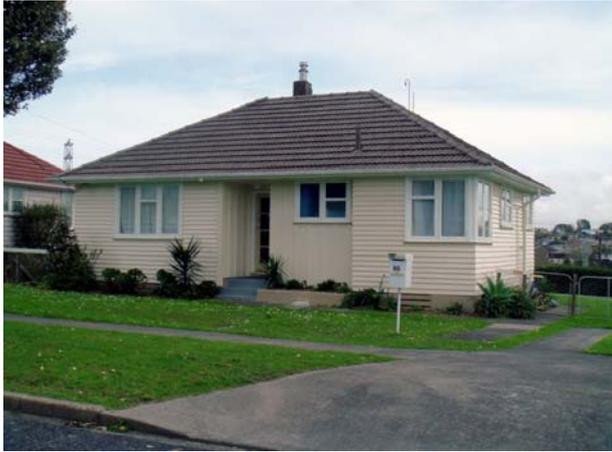
<p>House Type State House (1 group suggested two typologies which included early state housing and another subtype which could be branded the “50’s classic”)</p>

Basic description		
	<p>House Form ≤100m², detached Hipped roof, square single story home Small homes — average size 87m²</p>		
	<p>Main construction type/materials New Zealand materials (aim to minimise inputs). “Sound bones”</p>		
	<p>Estimated percentage Number of storeys</p>		
<p>Era/age 1937–1965 (the classic). State houses built till now This picture covers houses pre-1950. After >1950 more variation in typology. 1930–1950 [note this era of house is the subject of extensive work by Bob Lloyd]</p>	<p>1 storey 75% (some discrepancy between groups with one group estimating 100% 1 storey)</p>	<p>2 storey 25%</p>	<p>3 storey</p>
<p>Main system features Orientation/layout can be constraining especially with private state house “typology” Architecturally designed, oriented to the sun with living areas facing north</p>		<p>Significant variations (if significant then add to possible sub types below)</p>

<p>Floors Suspended wooden (good quality), suspended timber rimu and matai, variable ground clearance norm over 600 mm</p>		<p>Nil</p>	
<p>Walls Timber framing: cladding timber (40%), brick (40%), fibrolite (<5%), stucco (15%) Timber framed typically weatherboard but some brick and some stucco over chicken mesh, no building paper, no insulation</p>		<p>Nil</p>	
<p>Ceilings Pinex standard stud, some with features such as cornices 2.7 m ceiling, mostly insulfluffed,</p>		<p>Nil</p>	
<p>Glazing Smaller windows in earlier (saving imported glass), later “50s classic” bigger windows), wooden frames Wooden framed single glazed windows, 15–20% glazing with good eaves</p>		<p>Nil</p>	
<p>Roof</p>		<p>Nil</p>

Can we say anything in relation to ease of retrofit to Beacon HSS™?	Problem can over capitalise. Retrofitting the additions
<ul style="list-style-type: none"> • Energy — excellent • Access to ceiling often through a wardrobe or through laundry so size of product is an issue. Cavity is sufficient for good insulation in ceiling and underfloor • Need for heat transfer systems to adequately heat the whole house • Really hard to retrofit with pellet burners or stand alone wood burners as rooms are so small – takes up a lot of room • Insulfluff often with unwholesome biota so no fun to retrofit in ceilings 	
<ul style="list-style-type: none"> • Water — easier, good roof structure, land for tank 	
<ul style="list-style-type: none"> • Waste 	
<ul style="list-style-type: none"> • IEQ 	
<ul style="list-style-type: none"> • Materials 	
Potential subtypes based on variations There are art deco “look-a-likes”	Significant? YES Estimated % of stock 40%

Typology	Heat pump	Low emission wood burner	Pellet burner	Heat transfer systems
State house (1930–1970)	<ul style="list-style-type: none"> - Not dependent on typology — must insulate first - Reasonable solution 	<ul style="list-style-type: none"> - Floor space issue in some homes if smaller - watch regional air shed requirements (common to all houses — i.e. not dependent on typology) 	<ul style="list-style-type: none"> - Small rooms — noise from fans may be an issue - Space in small homes - Probably require a heat transfer system to fully warm the house beyond the single room 	<ul style="list-style-type: none"> - Easy roof space — good option, great solution if original closed plan still existing - Good option because of smaller room size
1960s Multi unit housing	<ul style="list-style-type: none"> - Yes — single and correctly sized unit 	<ul style="list-style-type: none"> - Not enough space 	<ul style="list-style-type: none"> - Not enough space 	<ul style="list-style-type: none"> - Not useful nor space in cavity

Typology	Solar hot water systems	Heat pump hot water systems	Wetback hot water systems
State house (1930–1970)	<ul style="list-style-type: none"> - Typically roof pitch OK - Orientation may be incorrect - May require strengthening in roof for hot water cylinder - Has roof space for cylinder - Efficiency a function of locality - Difficulties with installation on tiles (safety issues as tiles can not take weight) - In some areas low number of sunshine hours may make SHW unviable (applies to all typologies) - Small HW cupboard may make internal cylinder replacement problematic 	<ul style="list-style-type: none"> - Needs space outside close to service areas - Good option as kitchen and bathrooms close - No specific typology issues - HW cylinder has to be outside house as is generally quite large (applies to all typologies) 	<ul style="list-style-type: none"> - Space and layout are the main constraints - Hard to retrofit a wet back in because of small room sizes - May be an option if cylinder close to wood burner

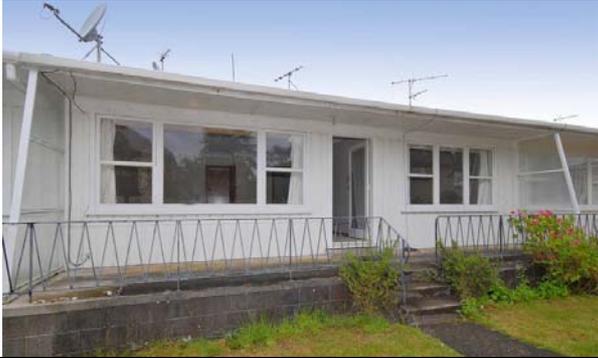
<p>House Type 1960s multi unit</p>

<p>Basic description</p>		
	<p>House Form Rectangular, no additions</p>		
	<p>Main construction type/materials Concrete block, concrete slab; timber frame joinery; rimu floorboards 4–6 inch; iron roof</p>		
	<p>Estimated percentage Number of storeys</p>		
<p>Era/age 1960s</p>	<p>1 storey All 100%</p>	<p>2 storey</p>	<p>3 storey</p>
<p>Main system features Non-renovatable/adaptable</p>		<p>Significant variations (if significant then add to possible subtypes below)</p>	
<p>Floors Low underfloor height if timber Concrete slab common</p>			
<p>Walls Block (8 inch) between units; light frame concrete block wall</p>		<p>Some firewalls go into ceiling cavity — some stop at 8 ft</p>	
<p>Ceilings Textured ceilings (asbestos) or pinex tiles</p>			
<p>Glazing Wood; single glazing; modulised</p>			
<p>Roof Corrogated iron/corrogated F Cement/asbestos low cavity space if any</p>

<p>Insulation None and difficult</p>			
<p>Heating system Some gas; electric night store; portable gas</p>			
<p>Other (e.g. garage under house common) No garage</p>			
<p>Can we say anything in relation to climate and/or region? Auckland, Christchurch and Wellington + provincial centres (i.e. not villages)</p>			
<p>Can we say anything in relation to ease of retrofit to Beacon HSS™?</p>			
<p>Energy Gas</p>			
<p>Water Low pressure; bath and showers; single flush; copper pipes; rotary clothes line; no lagging or HWC wraps</p>			
<p>Waste</p>			
<p>IEQ Humidity and cold</p>			
<p>Materials</p>

1960s Multi unit housing	<ul style="list-style-type: none"> - May be an opportunity to provide water from a single unit to a number of dwellings (but complicated by ownership issues) - not cost effective for single units 	<ul style="list-style-type: none"> - Not big enough to warrant these 	<ul style="list-style-type: none"> - No space for solid fuel burners

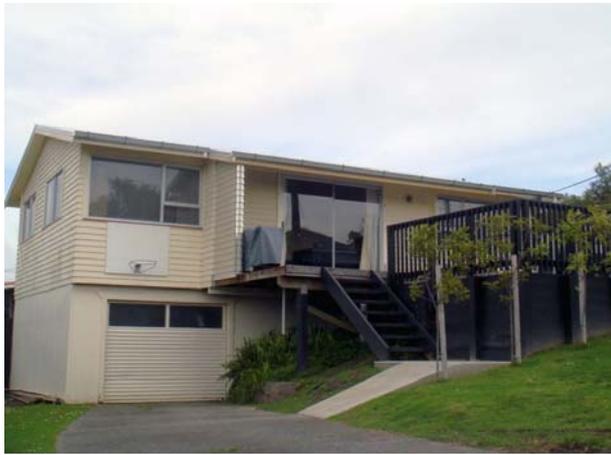
House Type 1970s house

Basic description		
	House Form		
	Main construction type/materials		
	Estimated percentage Number of storeys		
Era/age 70s House (1970–1978, pre-insulation)	1 storey 95%	2 storey 5%	3 storey
Main system features		Significant variations (if significant then add to possible subtypes below)	
Floors Predominantly timber/chipboard — some concrete			
Walls Light timber frame, foil backed Gib, concrete block		Foil backed Gib a problem	
Ceilings Skillion roofs have sarked ceilings			
Glazing First aluminium, some glazing floor to ceiling, sliding doors			
Roof Predominantly pitched, some skillion			
Insulation Little insulation		May find some limited retrofit attempts	
Heating system Fires, the first log burners appear, night store heaters, panel heaters			
Other (e.g. garage under house common)			
Can we say anything in relation to climate and/or region? Regionally and budget dependent — brick weatherboard and fibro cement

Can we say anything in relation to ease of retrofit to Beacon HSS™?		A frames are pigs and should be demolished — Beacon to supply counselling...	
Energy Underfloor OK except for concrete Skillions problematic

70s House (1970–1978, pre-insulation)	<ul style="list-style-type: none"> - Easy 	<ul style="list-style-type: none"> - Easy if fireplace existing (replace flue) - Relatively cheap 	<ul style="list-style-type: none"> - Easy if fireplace existing (replace flue) 	<ul style="list-style-type: none"> - Easy to do low wattage - Should use insulated ducting (applies to all houses, not dependent on typology)
80s House (1978–1989)	<ul style="list-style-type: none"> - No issues — prime candidates - Noise issues if close to neighbouring properties 	<ul style="list-style-type: none"> - Replace existing wood burner if present (probably needs replacing and may not be efficient) 	<ul style="list-style-type: none"> - Replace existing wood burner if present 	<ul style="list-style-type: none"> - Sometimes not enough space — not possible in skillion roof - Focus on the middle part of the house
Early 90s (1990–1996)	<ul style="list-style-type: none"> - Reasonable solution if required 	<ul style="list-style-type: none"> - Reasonable solution if required 	<ul style="list-style-type: none"> - Reasonable solution if required 	<ul style="list-style-type: none"> - Not possible in skillion roof

Simple roof form
 % rafter — load bearing walls
 % truss?
 % skillion — partial skillion split level
 A frame
 Large # std design — state advance/state house
 Smaller # architect leading edge — new ideas/products (skylights)
 Light timber frame
 Block basements — some concrete floors
 Aluminium windows
 Chipboard replaces timber flooring

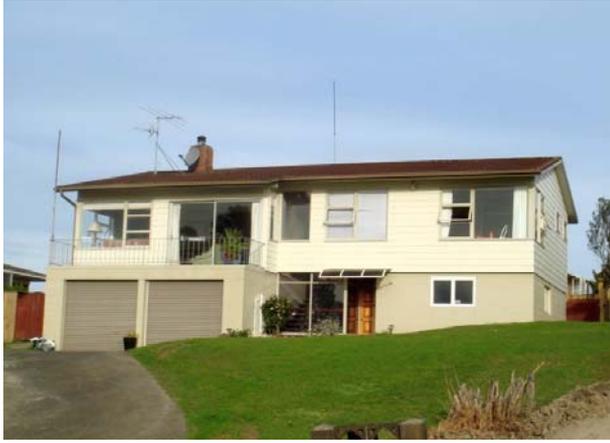
<p>House Type 1980s house</p>

<p>Basic description</p> <ul style="list-style-type: none"> • Timber frame maximising space • Larger rooms — more open plan • Little style — diversity 		
	<p>House Form</p> <ol style="list-style-type: none"> 1. Beazley box 2. Large suburban house 3. Mediterranean 		
	<p>Main construction type/materials</p> <ul style="list-style-type: none"> • Timber frame — pine (treated) • Cladding — wood fibreboard, brick veneer • Roof — iron 		
	<p>Estimated percentage Number of storeys</p>		
<p>Era/age 1978–1989 (post insulation upgrade in Building Code)</p>	<p>1 storey most houses</p>	<p>2 storey very few</p>	<p>3 storey very few</p>
<p>Main system features</p>		<p>Significant variations (if significant then add to possible sub types below)</p>	
<p>Floors</p> <ul style="list-style-type: none"> • Custom wood floors • Some pine • Vinyl and asbestos backing • Suspended floors with fair access

<p>Walls</p> <ul style="list-style-type: none"> • Timber frame cavity — insulation in some (not all — but required!) • GIB-lined • Insulation insufficient 			
<p>Ceilings</p> <ul style="list-style-type: none"> • Plasterboard 			
<p>Glazing</p> <ul style="list-style-type: none"> • Single glazed aluminium windows 			
<p>Roof</p> <ul style="list-style-type: none"> • Difficult access/small cavity 			
<p>Insulation</p>			
<p>Heating system</p> <ul style="list-style-type: none"> • Generation 1 wood burners (closed, Kent) • Sometimes no fix heating • Night store • Convection • Underfloor heating 			
<p>Other</p> <ul style="list-style-type: none"> • Garage — attached to the house • Move away from eaves and other protection from houses • Overheated? • Conservatories • Large windows — often problem with glare

80s House (1978–1989)	<ul style="list-style-type: none"> - Flatter roofs than is optimal - Orientation issues for many houses - Aesthetics could be a barrier - Roof construction may be able to hold bigger cylinders than previous typologies 	<ul style="list-style-type: none"> - No issues (dependent on space availability) - More space in this typology (large suburban sites) 	<ul style="list-style-type: none"> - Cluster of cylinder and heating - A number might already have a system installed - Retrofitting wet backs into existing wood burners is problematic
Early 90s (1990–1996, pre-revamped Building Code)	<ul style="list-style-type: none"> - No issue with installing on these houses 	<ul style="list-style-type: none"> - No issues 	<ul style="list-style-type: none"> - Requires appropriate air shed restrictions not to be a barrier

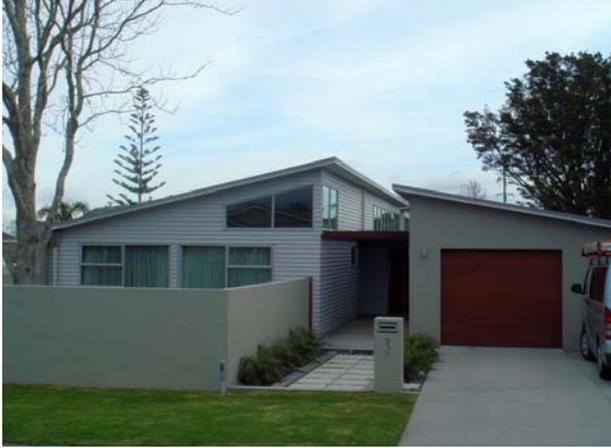
<p>House Type 1990s house — 1990–1996, pre-insulation changes to Code</p>

<p>Basic description</p>		
	<p>House Form Incredibly variable</p>		
	<p>Main construction type/materials Predominantly timber frame [untreated timber] Usually concrete slab on flat land, sometimes particle board floor on hills, predominantly metal roofs, some concrete tiles and sheet shingles (asphalt) and butyl rubber on flat roofs and bituminous torch on membranes on flat roofs</p>		
	<p>Estimated percentage Number of storeys</p>		
<p>Era/age 1990–1996</p>	1 storey	2 storey	3 storey
<p>Main system features</p>		<p>Significant variations (if significant then add to possible subtypes below)</p>	
<p>Floors Mostly concrete slab on flat land (uninsulated), sometimes suspended particle board on hillsides, suspended floors have foil draped underneath</p>			
<p>Walls Three main types: brick veneer, fake weatherboard (e.g. lineboards) and monolithic cladding (Insulclad® and polystyrene plaster system direct fixed to studs common, these are leaky buildings)</p>

<p>Ceilings Small ceiling cavity, tiled ceilings common in BOP</p>			
<p>Glazing Often 40% glazing in living areas, single glazed in aluminium windows, no louvres or overlights, minimal eaves</p>			
<p>Roof Generally low pitch and low ceiling stud (2.4 m) or trussed ceilings with small roof spaces</p>		<p>Whole subdivisions in Auckland and BOP of brick veneer and tiled homes</p>	
<p>Insulation To Code — sometimes a foil lined Gib product was used in walls — which is already failing; where suspended floors have foil draped underneath which is often failing</p>			
<p>Heating system Generally in northern parts of the country no in built heating systems.</p>			
<p>Other (e.g. garage under house common) Often multi level. Generally have electric hot water cylinders, but in</p>

Auckland can have instant gas or gas storage	
Can we say anything in relation to climate and/or region?	
Can we say anything in relation to ease of retrofit to Beacon HSS™?	
Energy — hard to retrofit insulation into ceiling due to lack of space, concrete slab floors relatively hard to retrofit, often a hazard of rot encountered during retrofits — these are often leaky buildings; orientation for the sun was not a consideration for these homes, therefore are often poorly oriented and cold	
Water	
Waste	
IEQ — generally have ventilation fans, these are often broken now	
Materials	
Potential subtypes based on variations	Significant? Estimated % of stock

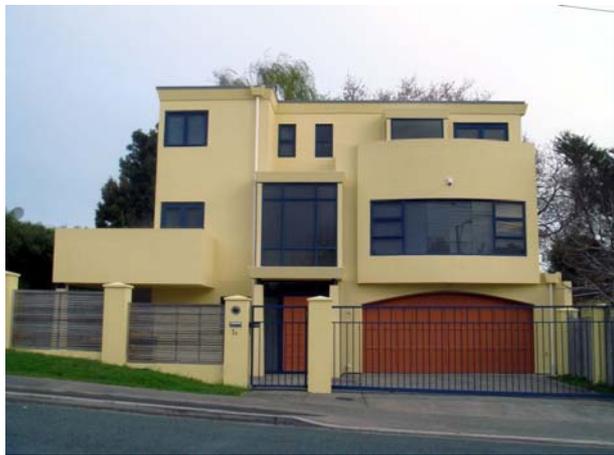
<p>House Type Last decade housing</p>

<p>Basic description Large and leaky; subdivisions; airtight; well insulated; orientation toward street; onset of multiunit residential</p>		
	<p>House Form Complete roof; multiple cladding</p>		
	<p>Main construction type/materials Timber framing; poly/mono claddings — flat sheet; cavity construction; aluminium joinery</p>		
	<p>Estimated percentage Number of storeys</p>		
<p>Era/age 1996–2007 (post-1996 insulation upgrade)</p>	<p>1 storey 40%</p>	<p>2 storey 50%</p>	<p>3 storey 10%</p>
<p>Main system features</p>		<p>Significant variations (if significant then add to possible subtypes below)</p>	
<p>Floors Concrete mostly; midfloor timber; particle board</p>			
<p>Walls Timber frame; steel frame; small number concrete; some lightweight timber frame</p>			
<p>Ceilings Ceilings with holes (downlights); only 90% insulated due to penetrations/timber</p>

<p>Glazing Aluminium, double glazing in south; not thermally broken; no longer have pelmets</p>			
<p>Roof Truss; metal claddings; some flat</p>			
<p>Insulation Well insulated — though lots of penetrations; uninsulated slab; downlights means not so effective insulation; no insulation in garage but mostly lined</p>			
<p>Heating system Many types; lpg; some underfloor; minimal pellet burners; heat pumps; A grade water cylinders</p>		<p>A grade water cylinders</p>	
<p>Other (e.g. garage under house common) Garage facing street and attached</p>			
<p>Can we say anything in relation to climate and/or region? Designs not site-specific</p>			
<p>Can we say anything in relation to ease of retrofit to Beacon HSS™? Big potential to reveal leaky homes issues when retrofitting</p>		<p>So many variants that it is difficult to know what you are dealing with</p>	
<p>Energy Size of houses requires large appliances needed</p>

Typology	Ceiling insulation	Wall insulation	Floor/underfloor insulation	Double/triple glazing
Last decade (1996–2007, post-insulation upgrade)	<ul style="list-style-type: none"> - Should already have sufficient although down lights may reduce performance considerably 	<ul style="list-style-type: none"> - Some may exhibit leaky building syndrome — so insulation may be water logged and in need of replacement 	<ul style="list-style-type: none"> - Too late - If it is there under slab only - Need to develop perimeter insulation solutions (1m) 	<ul style="list-style-type: none"> - Slimline — too late — often design for blinds - Pelmet may assist performance but not the “look”

Typology	Heat pump	Low emission wood burner	Pellet burner	Heat transfer systems
Last decade (1996–2007, post-insulation upgrade)	<ul style="list-style-type: none"> - Are efficient in some climates but not necessarily all (applies to all typologies) - In Auckland the high humidity may lead to extra costs 	<ul style="list-style-type: none"> - No problem 	<ul style="list-style-type: none"> - No problem 	<ul style="list-style-type: none"> - Barrier may be size of house

Typology	Solar hot water systems	Heat pump hot water systems	Wetback hot water systems
Last decade (1996–2007, post insulation upgrade)	<ul style="list-style-type: none"> - More problems — roof spaces more complex - Cylinder requires right insulation and to be sized correctly - Consent costs and delays are barriers 	<ul style="list-style-type: none"> - No issues 	<ul style="list-style-type: none"> - EE wood burners + wet back component an option - Requires appropriate air shed restrictions not to be a barrier — models should be selected carefully

1990s big leakers — retrofit may reveal bigger issues — nightmare
 More research on healthy houses? (for modern houses)
 Over heating in summer
 Assume well insulated
 Air tight/poorly ventilated
 Formaldehyde
 Complex software generating roof structure
 Double garage and standard (integral)
 Enclosed decks (over living)
 Covenants in subdivision — large subdivision — gated communities
 No eaves/parapets/integral gutter/internal of fascia gutter
 Concrete landscape
 Light steel frame (6%)
 Sealed not ventilated
 Non thermal break aluminium joinery
 \$\$ on visible parts of house
 Garage faces street
 Large openings
 Monolithic cladding/kiln dried untreated timber frame
 Large number of downlights
 High pressure hot water
 Lots of appliances
 Underfloor heating/concrete floor
 Top soil removed from site
 Two lounge rooms
 Level entry — high ground level
 Uninsulated garage/lined
 Plethora of materials/junctions/complexity
